Phase I Environmental Site Assessment

**Harbor Drive Property
APN 450-790-29
San Diego, California**

Rincon Consultants, Inc.
April 27, 2015

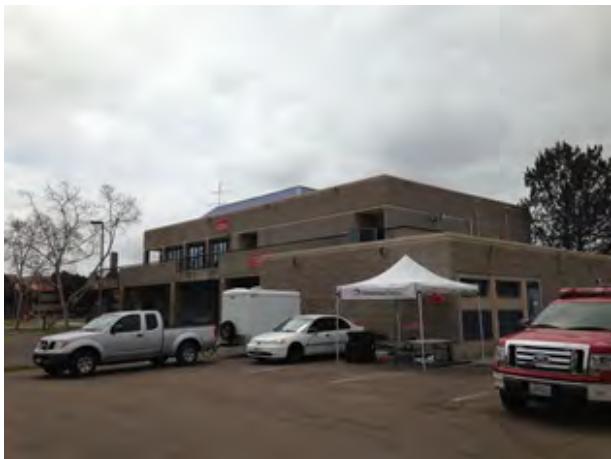
Photograph 1. View of the exterior of a building used by the fire department.

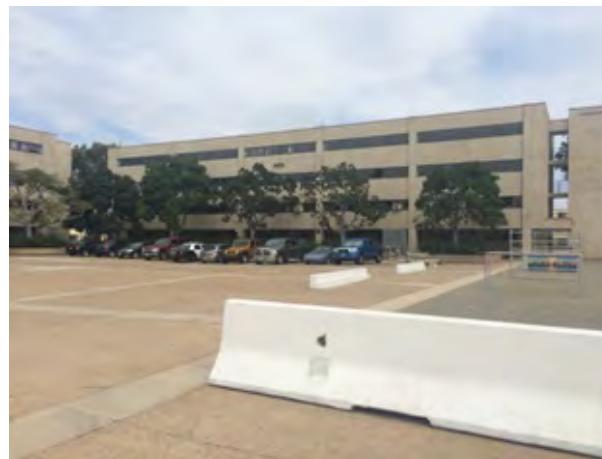
Photograph 2. View of the exterior of building 480, used by the police department.

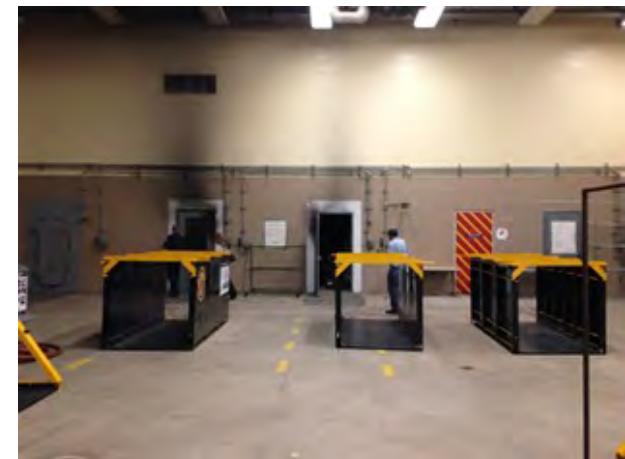
Photograph 3. View of a specialized training room on the subject property, located on the northern portion of the subject property, in building 609.

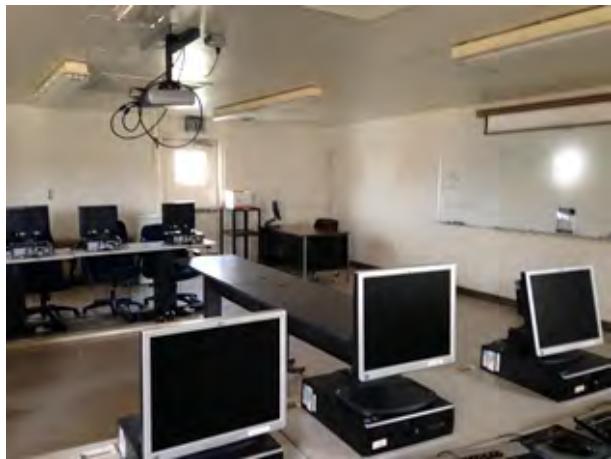
Photograph 4. View of a computer lab located on the northern portion of the subject property, in building 611.

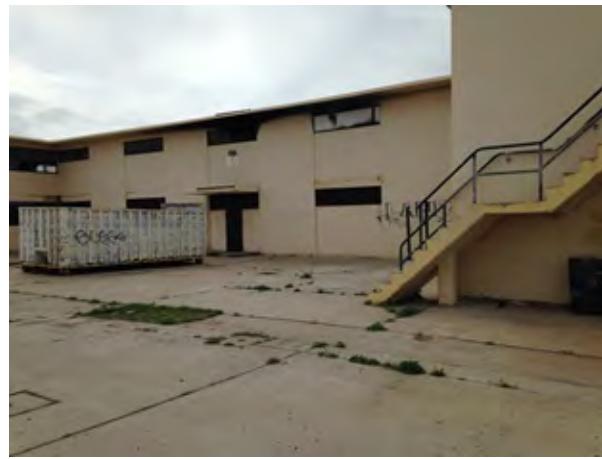
Photograph 5. View of H-barracks on the subject property.

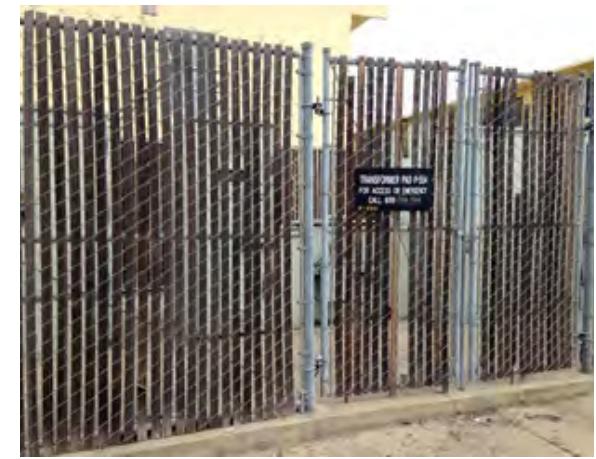
During the site reconnaissance, Rincon observed three transformers on the subject property. One was observed along Kincaid Road, to the west of building 89C. The other two transformers were located on the southern half of the subject property, between the eastern and western H-barracks.

Photograph 6. View of a transformer located on the subject property.

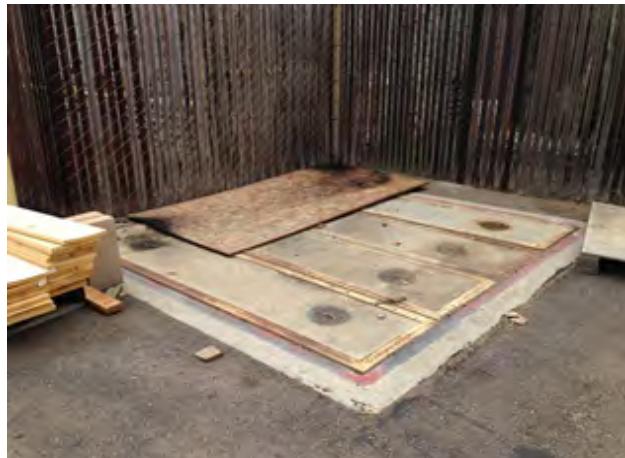
Unknown Underground Feature – During the site reconnaissance, an unknown underground feature was observed at the northeast corner of building 609. Based on our interview with Mr. Gaboury, he was not aware of its function.

- C. ***Unknown underground feature north of building 609*** - During the site reconnaissance, an unknown underground feature was observed on the northern portion of the subject property, north of building 609. The site manager was unaware of the purpose of this underground feature. Therefore, based on the unknown nature of feature, the unknown underground feature is considered an unknown environmental condition.

Photograph 7. View of the unknown underground feature located on the subject property, at the northeast corner of building 609.

To evaluate the subject property impact associated with the unknown underground feature present to the north of building 609, Rincon recommends obtaining further information from the City of San Diego, if possible, regarding its former use/purpose.

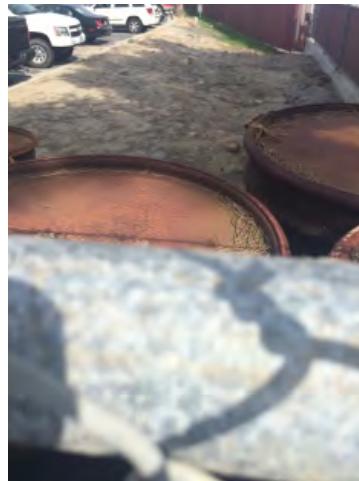
- B. ***Drum storage on the subject property*** - During the site reconnaissance, a drum storage area was observed on the subject property on the easternmost portion of the subject property, east of McCain Road. However, the drums are reported to be empty and are reported to have always been empty since being located on the subject property. Therefore, the drum storage on the subject property is considered de minimis.

Photograph 8. View of the drums located on the subject property, east of McCain Road.

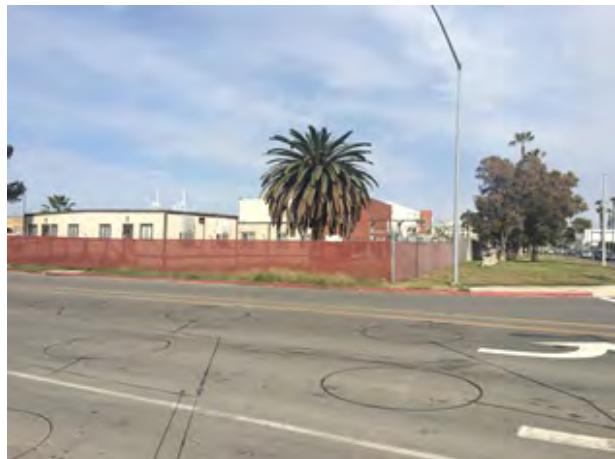
Photograph 10. View of the eastern adjacent property.

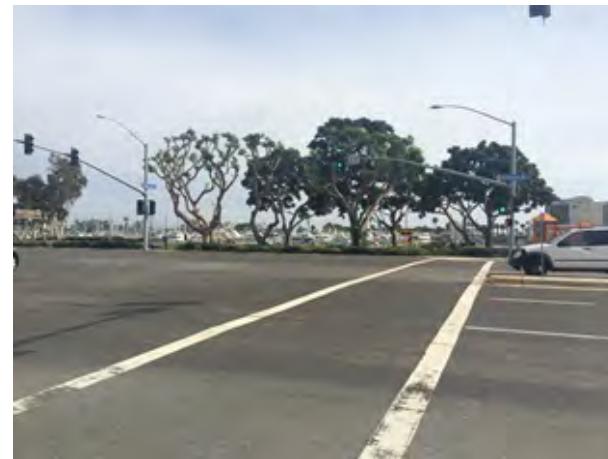
Photograph 11. View of the southern adjacent property.

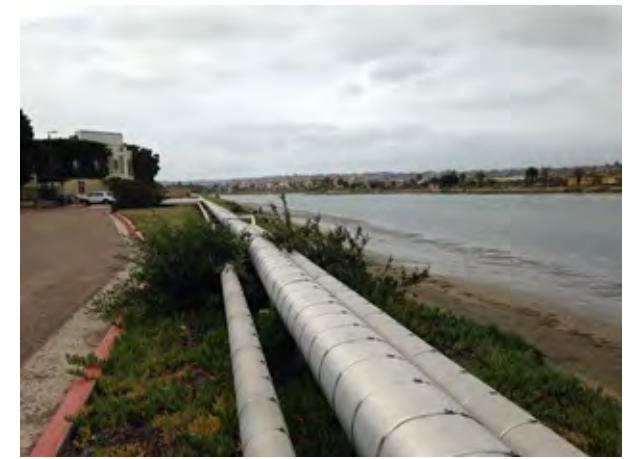
Photograph 12. View of the high pressure steam pipeline and the adjacent property to the west.
